6 National Dam Inspection Program. Saw
Mill Dam (NDS ID PA 00324 DER ID 46-261),
Delaware River Basin, Saw Mill Creek,
Montgomery County, Pennsylvania. Phase
I Inspection Report.

SAW MILL DAM, MONTGOMERY COUNTY
PENNSYLVANIA

NDS I.D. NO. PA 00324
DER I.D. NO. 46-261

PHASE I INSPECTION REPORT
NATIONAL DAM INSPECTION PROGRAM

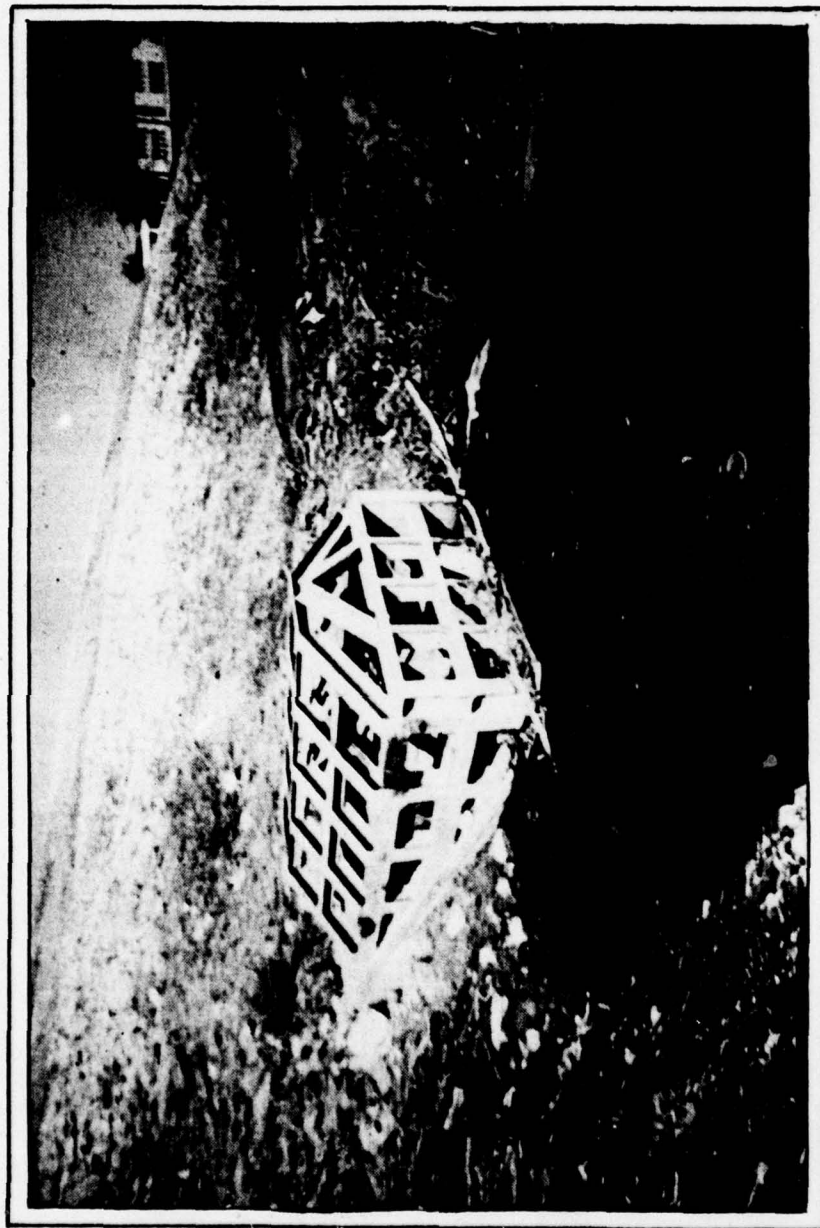
PHOTOGRAPH NO. 1

VIEW OF GATED PRINCIPAL INTAKE
STRUCTURE SHOWING TRASH RACK.
NOTE TRASH ACCUMULATIONS.
